**ROAD MARKINGS TO INCREASE ROUNDABOUT  
LANE UTILIZATION AND SAFETY IN CYPRUS**

**Alex Avgoustis**  
Executive Engineer  
Public Works Department  
Ministry of Communications & Works  
Republic of Cyprus

Prepared for: Transportation Research Board National Roundabout Conference  
Kansas City, Missouri, USA  
May 18-21, 2008

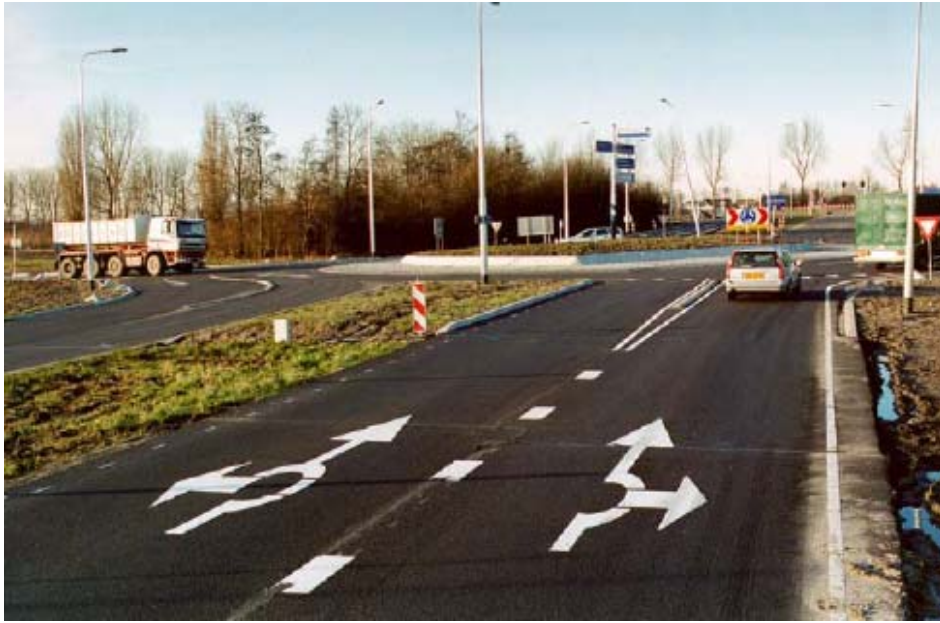
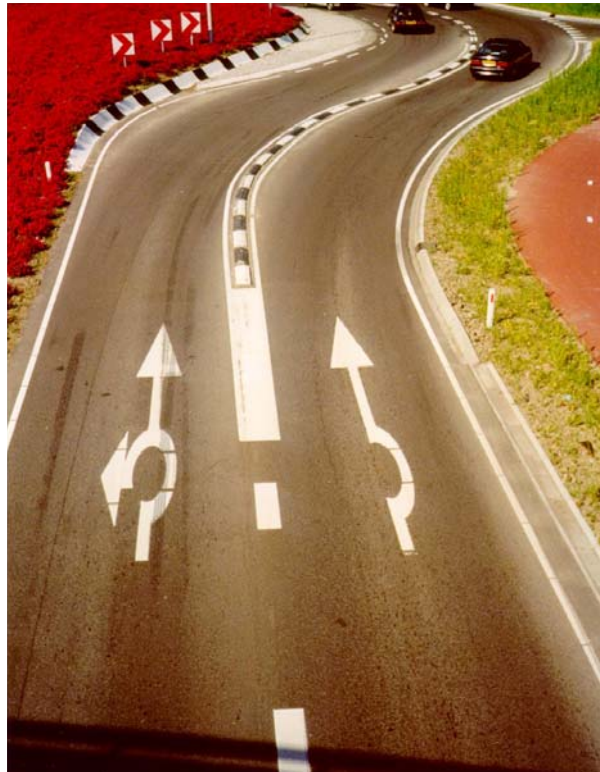
**FIGURE 5** Lane Use Arrows in The Netherlands  
(counter-clockwise traffic)

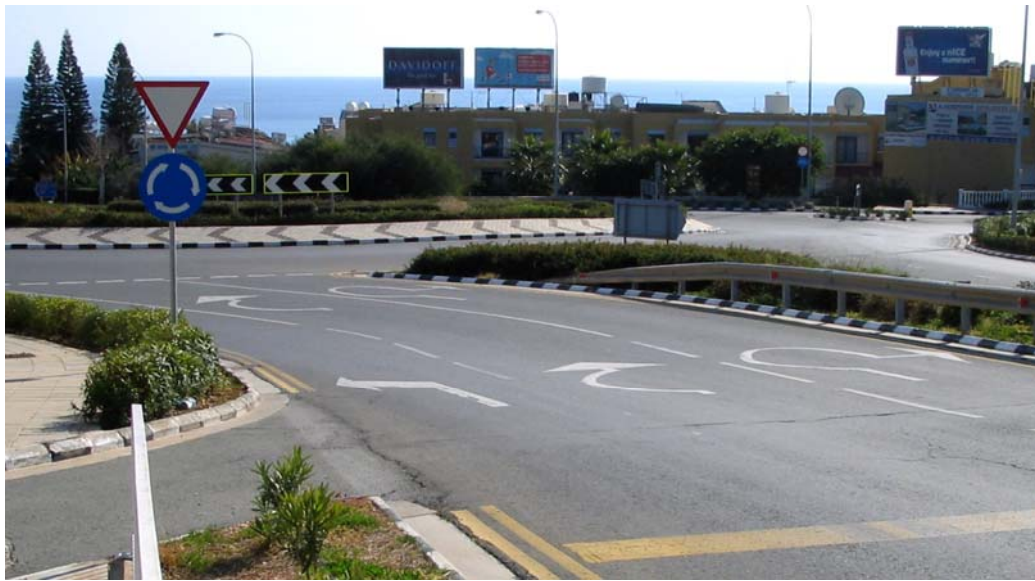
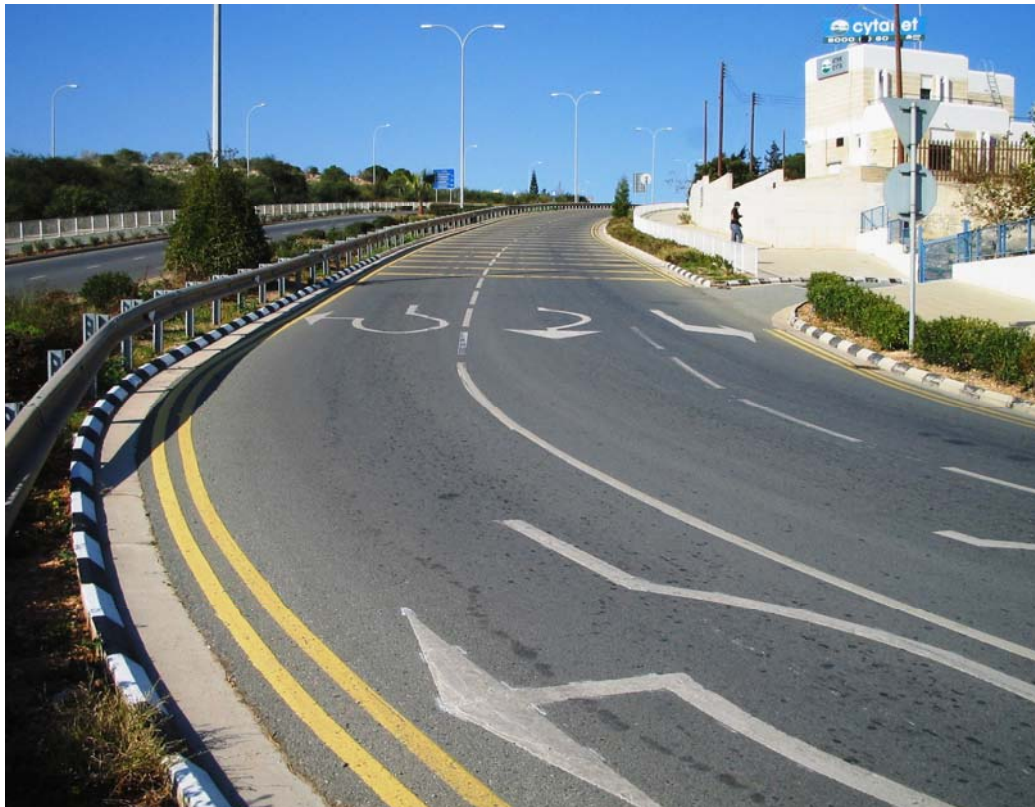
**FIGURE 9** Lane Arrows at Ayia Napa Roundabout in Cyprus (Photos)  
**(clockwise traffic)**

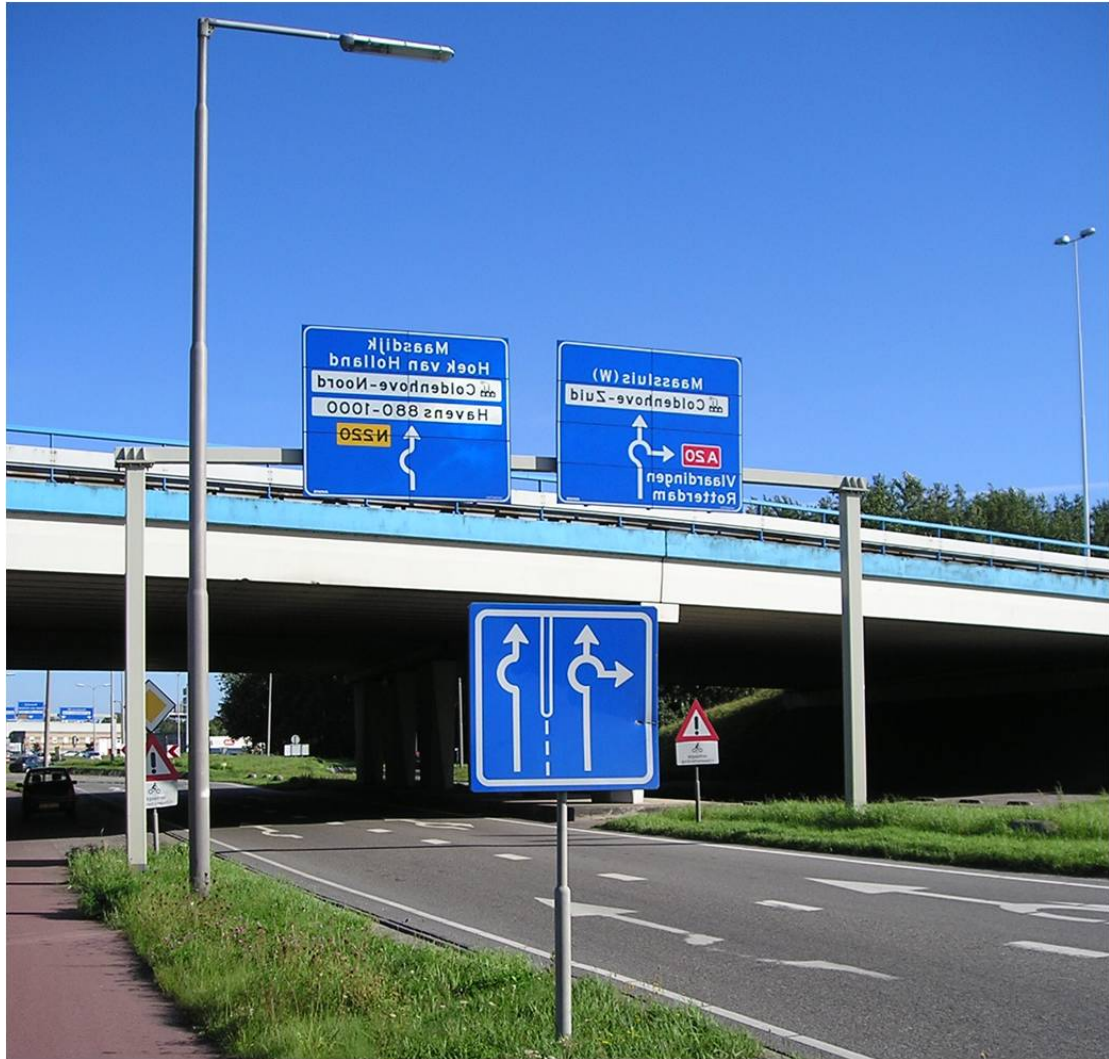
**FIGURE 11** Road Signs to assist entry lanes at roundabouts in The Netherlands (note: image is reversed)
