Walnut Lane Traffic Circle Retrofit

Submitted for presentation at the 4th TRB International Roundabout Conference
Seattle, WA
April 16-18, 2014

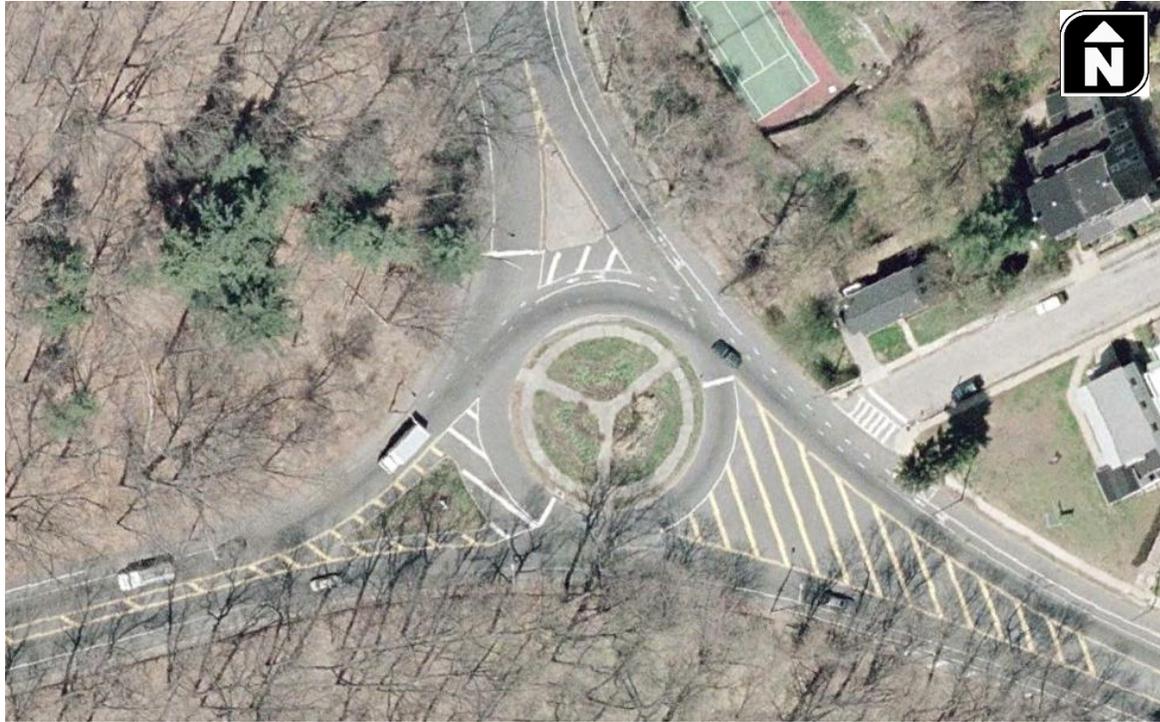
The intersection was originally a traffic circle with stop-control for Park Line Drive and free through movement on Walnut Lane. This control is shown in Figure 2. It was converted into roundabout control (yield-on-entry) around 2005, and the current geometry and pavement markings are shown in Figure 3.

Figure 2: Stop-Controlled and Free-flowing approaches to traffic circle prior to 2005. (© Google Earth)

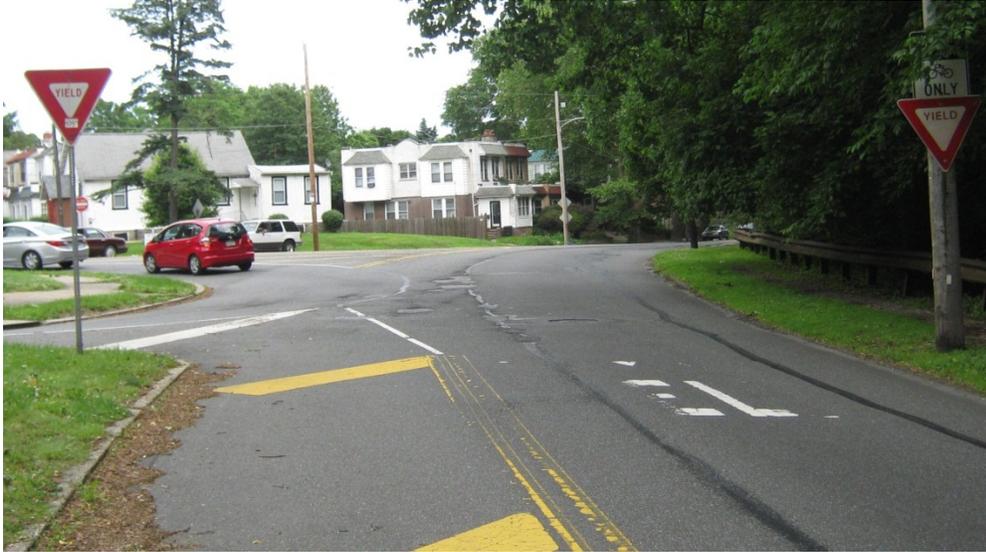
- The large radii of roadway curvature of some approaches and lack of deflection, as shown in Figure 4, allows vehicles to make through movements with little or no deflection or speed reduction. Fastest path speeds exceed the NCHRP Report 672 recommended threshold of 25 miles per hour for a single-lane roundabout

Figure 4: Lack of deflection on west leg entry

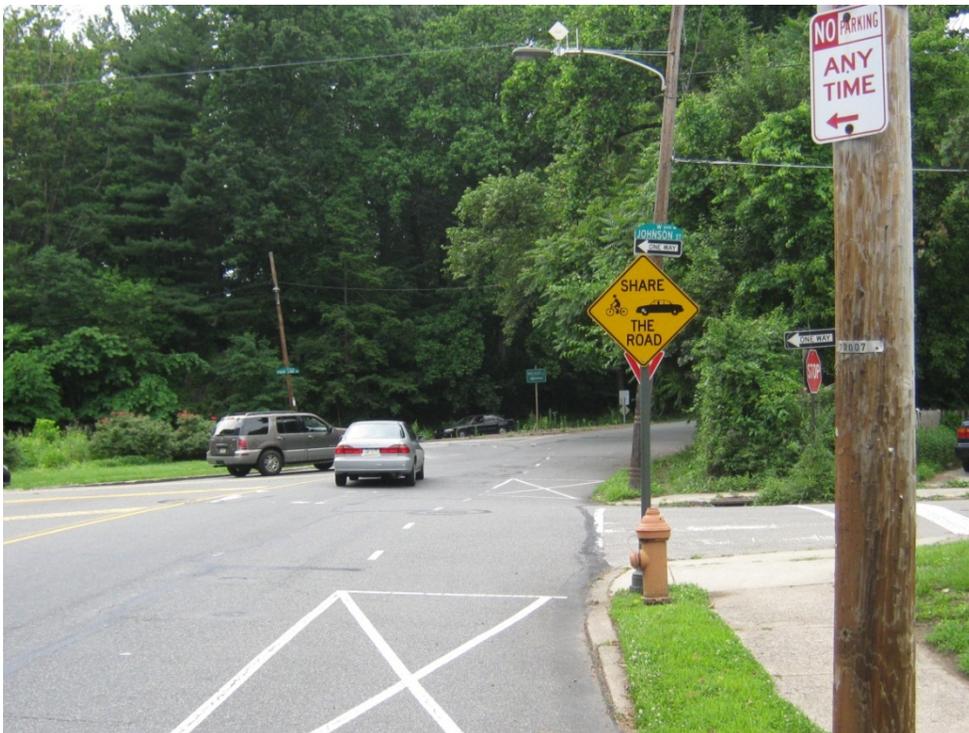
- The circulatory roadway is wider than one lane in some places despite all entries/exits having only one lane. As shown in Figure 5, this can confuse vehicle priority.

Figure 5: Wide lanes confuse priority

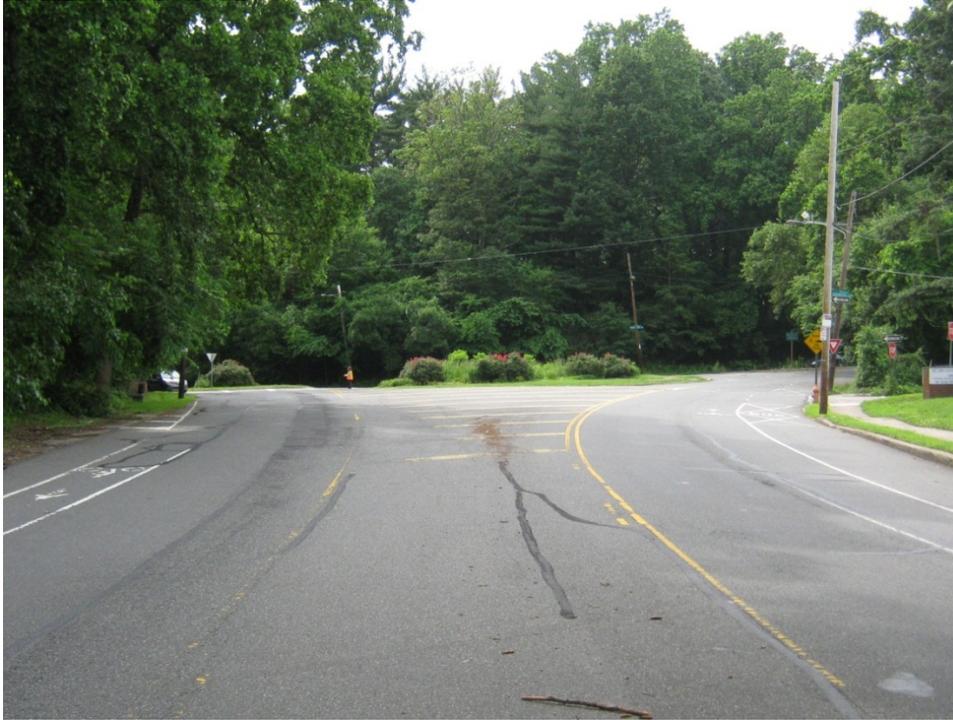
- There are no crosswalks on the intersection legs, and pedestrians are directed into the central island.
- The east leg, shown in Figure 6, does not have a splitter island. The roadway widens to approximately 100 feet near the traffic circle, making it difficult for pedestrians to cross this leg and travel between the residential area to the north and the park to the south. If a splitter island existed on this leg, it would restrict access from Johnson Street. Johnson Street is one-way southbound (towards the circle area), and left and right turns from Johnson Street to Walnut Lane are currently permitted.

Figure 6: Wide roadway and lack of splitter island on east leg

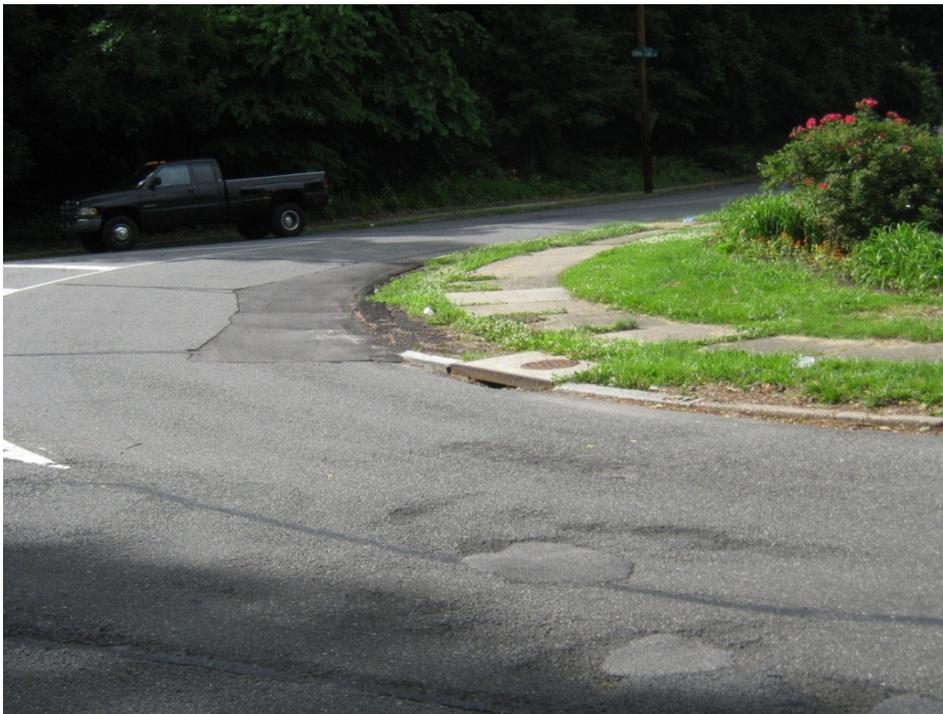
- Large vehicles appear to off-track into the central island. Damaged central island curb is shown in Figure 7.

Figure 7: Damaged central island curb

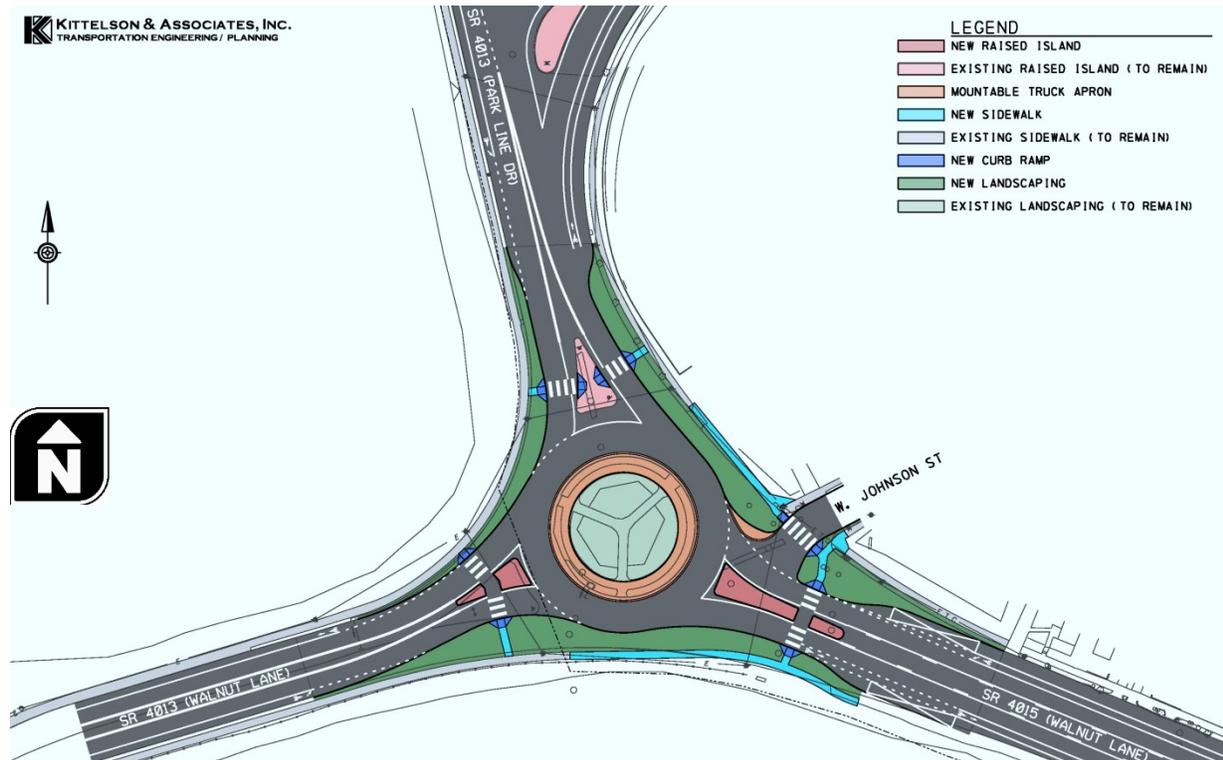
- Outside curbs on the entries and exits are moved in to narrow lane widths, increase deflection, provide speed control, and shorten pedestrian crossing distances.

- The splitter island on the west leg is relocated to increase deflection and provide speed control.
- A splitter island is added on the east leg.
- The bicycle lane is removed from the roundabout, and striping directs bicyclists to ride in travel lanes within the roundabout.

- Pedestrian crossings and curb ramps are added on each leg.
- A truck apron is added to the central island. The inside edge of the truck apron is located at the current inside edge of pavement of the sidewalk. The truck apron will accommodate WB-67s and removal of the sidewalk will discourage pedestrians from using the central island.

- Bus stops were moved outside of the circle
- Johnson Street, which is currently one-way southwestbound, is converted to right-out access.

These improvements are shown in Figure 10.

Figure 10: Concept Improvements

The concept plan shown in Figure 10 was presented to the Blue Bill Hill Civic Association in October 2013. Residents of Johnson Street raised several concerns related to emergency vehicle access and traffic flow in the event of a broken down vehicle within the circulatory roadway. In response to these concerns, the splitter island on the east leg (in front of Johnson Street) was changed to a mountable design to allow left-turns by emergency vehicles.
