**ROAD MARKINGS TO INCREASE ROUNDABOUT  
LANE UTILIZATION AND SAFETY IN CYPRUS**

**Alex Avgoustis**  
Executive Engineer  
Public Works Department  
Ministry of Communications & Works  
Republic of Cyprus

Prepared for: Transportation Research Board National Roundabout Conference  
Kansas City, Missouri, USA  
May 18-21, 2008

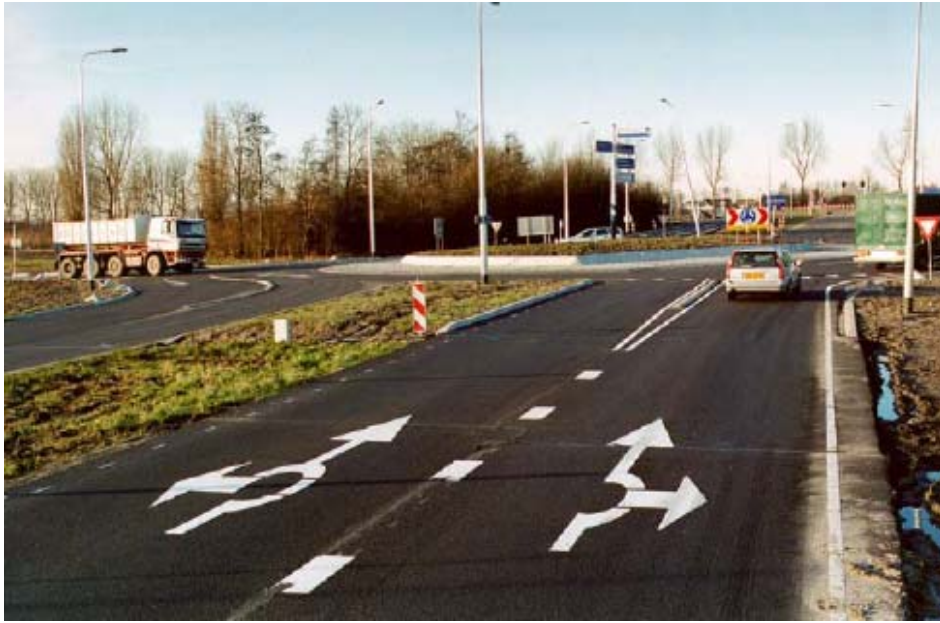
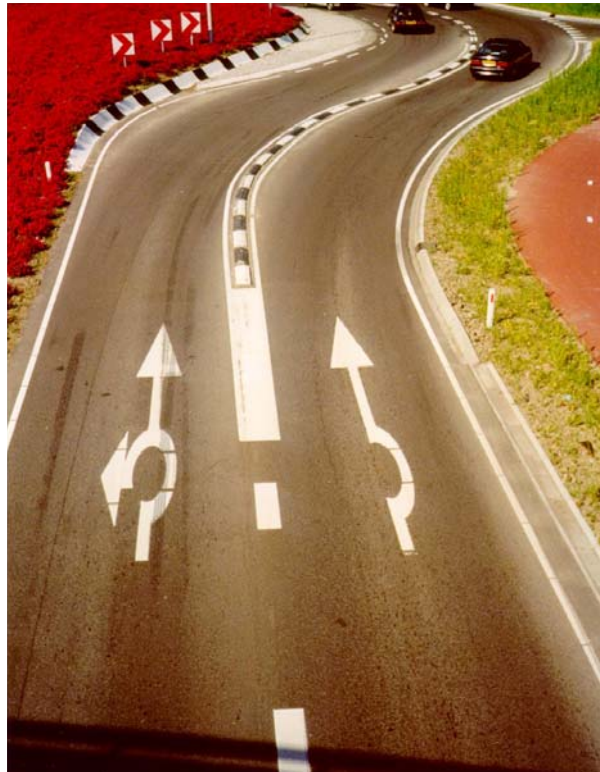
**FIGURE 5** Lane Use Arrows in The Netherlands  
(counter-clockwise traffic)

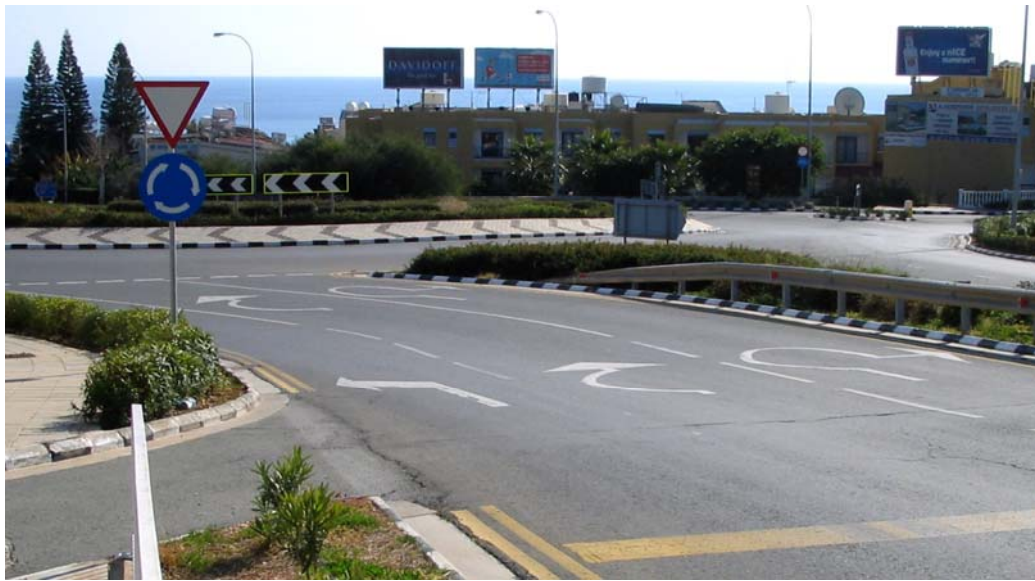
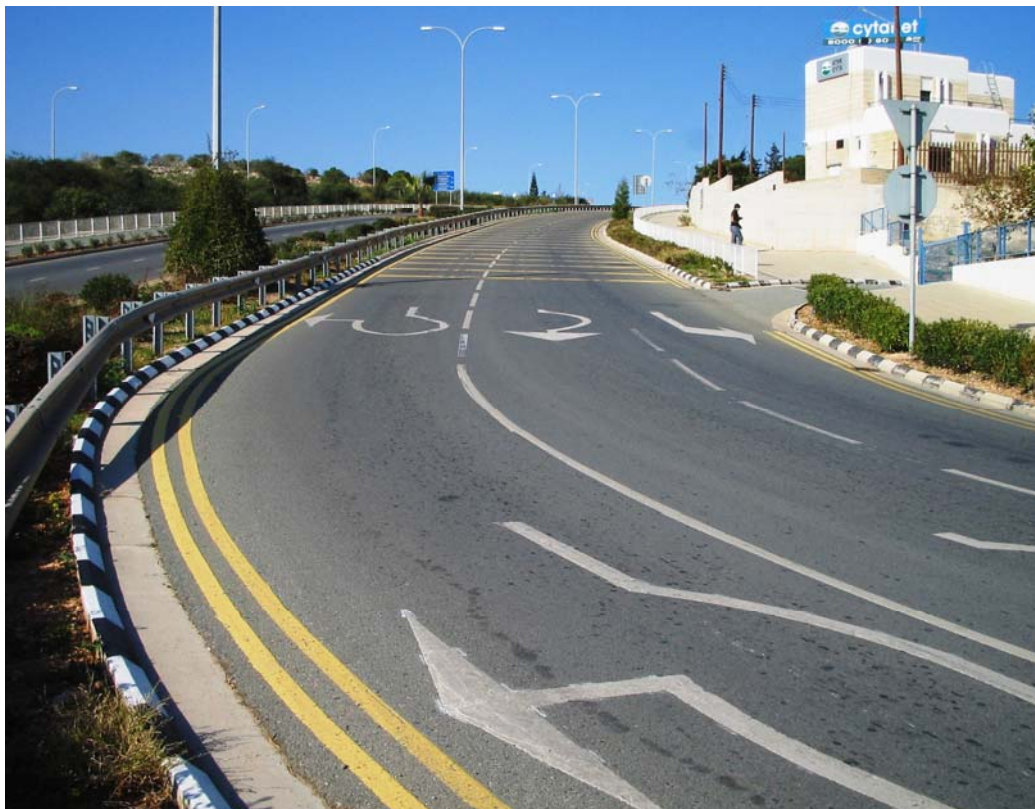
**FIGURE 9** Lane Arrows at Ayia Napa Roundabout in Cyprus (Photos)  
**(clockwise traffic)**

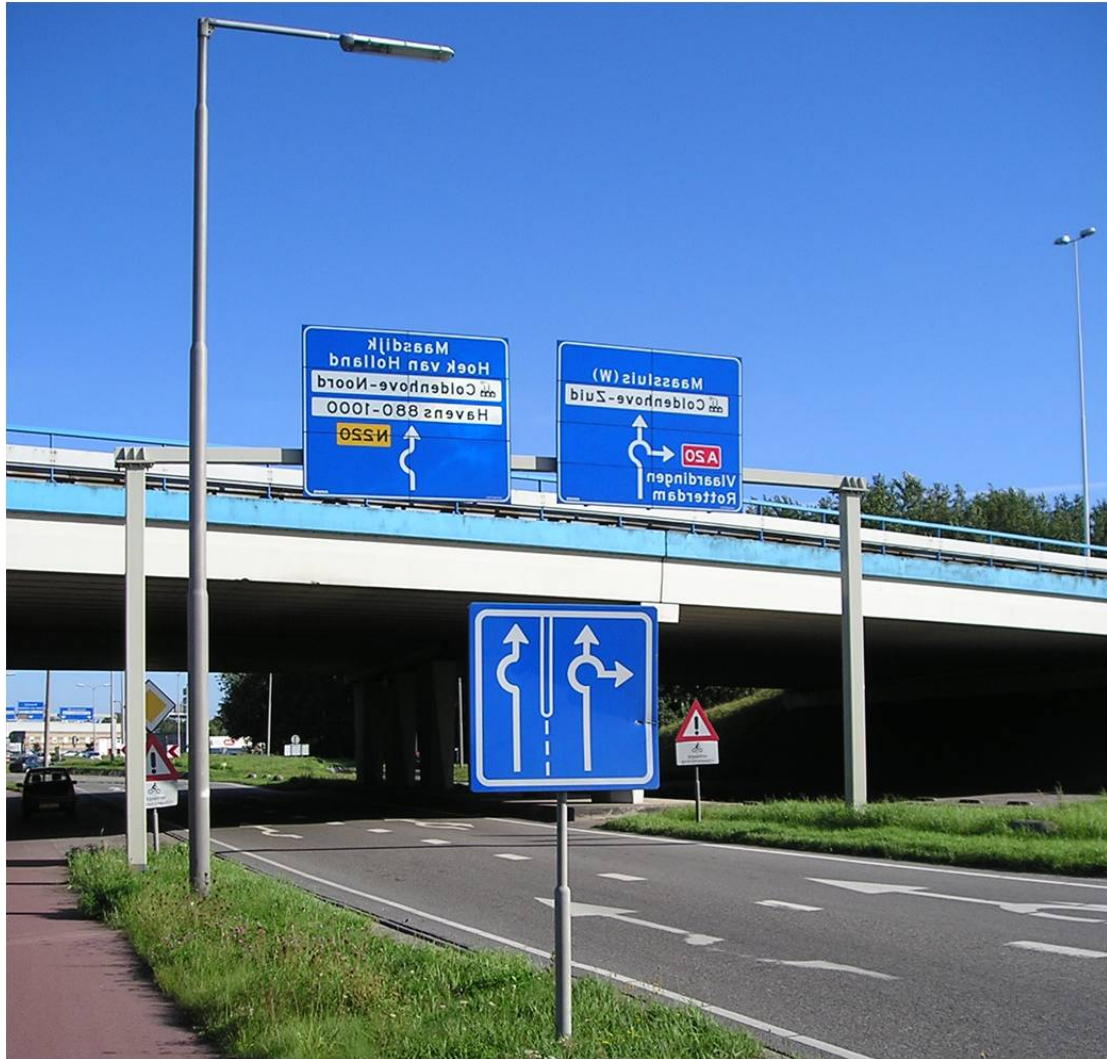
**FIGURE 11** Road Signs to assist entry lanes at roundabouts in The Netherlands  
(note: image is reversed)
