**ROAD MARKINGS TO INCREASE ROUNDABOUT  
LANE UTILIZATION AND SAFETY IN CYPRUS**

**Alex Avgoustis**  
Executive Engineer  
Public Works Department  
Ministry of Communications & Works  
Republic of Cyprus

Prepared for: Transportation Research Board National Roundabout Conference  
Kansas City, Missouri, USA  
May 18-21, 2008

Topic: Signing, Marking and Design for Efficient Operation and Safety

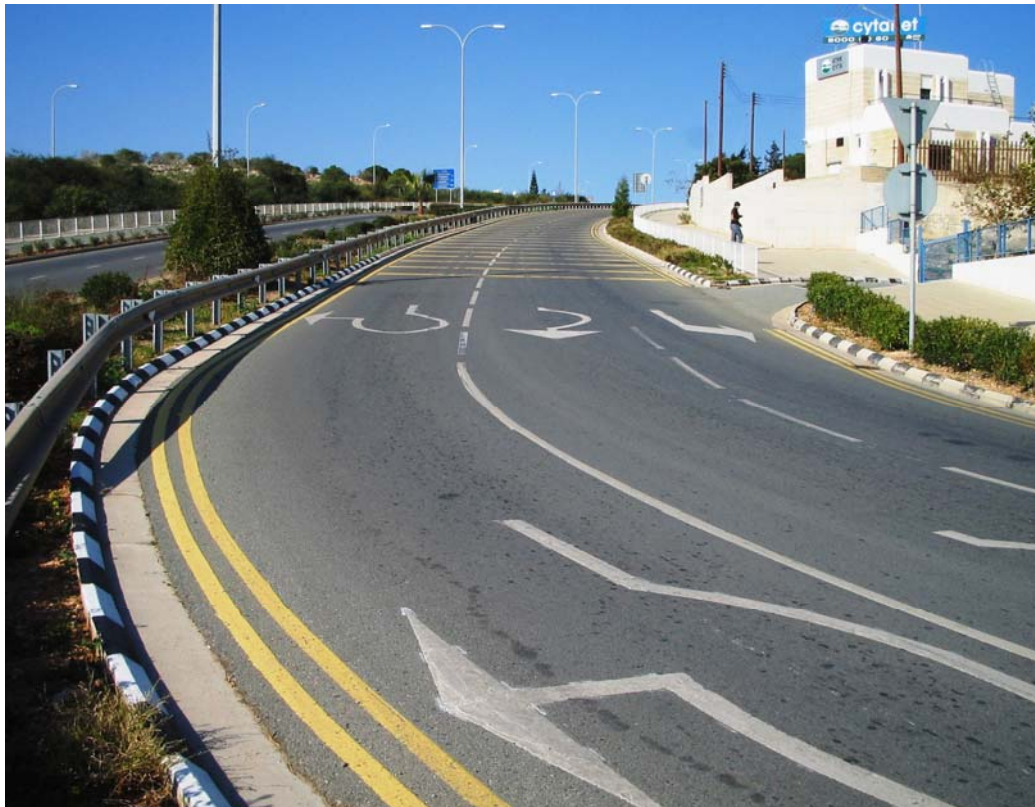
**FIGURE 9** Lane Arrows at Ayia Napa Roundabout in Cyprus (Photos)  
**(clockwise traffic)**

A detailed study to examine the extent of the benefits caused by the arrows installed and additional signage has not yet been completed but early results and feedback given by local motorists as well as the District Engineer who implemented them are very positive. It must be noted that many tourists and non-Cypriots use this roundabout especially during the summer months, so markings and signage are necessary in order for a motorist who is not familiar with the directions and the roundabout itself to understand which lane they should be in. When observing the traffic for a consecutive period of time one can easily see that the majority of motorists use the inside lane (far right) that leads into the town of Ayia Napa and move in the correct direction according to the arrows. A recommendation is to install the arrows at all entries to this roundabout after the pilot phase is completed.
